Sandia National Laboratories/New Mexico

**PROPOSALS FOR NO FURTHER ACTION
ENVIRONMENTAL RESTORATION PROJECT
SWMUs 16, 228A, 65A, 65B, 65C, AND 94E**

September 1999

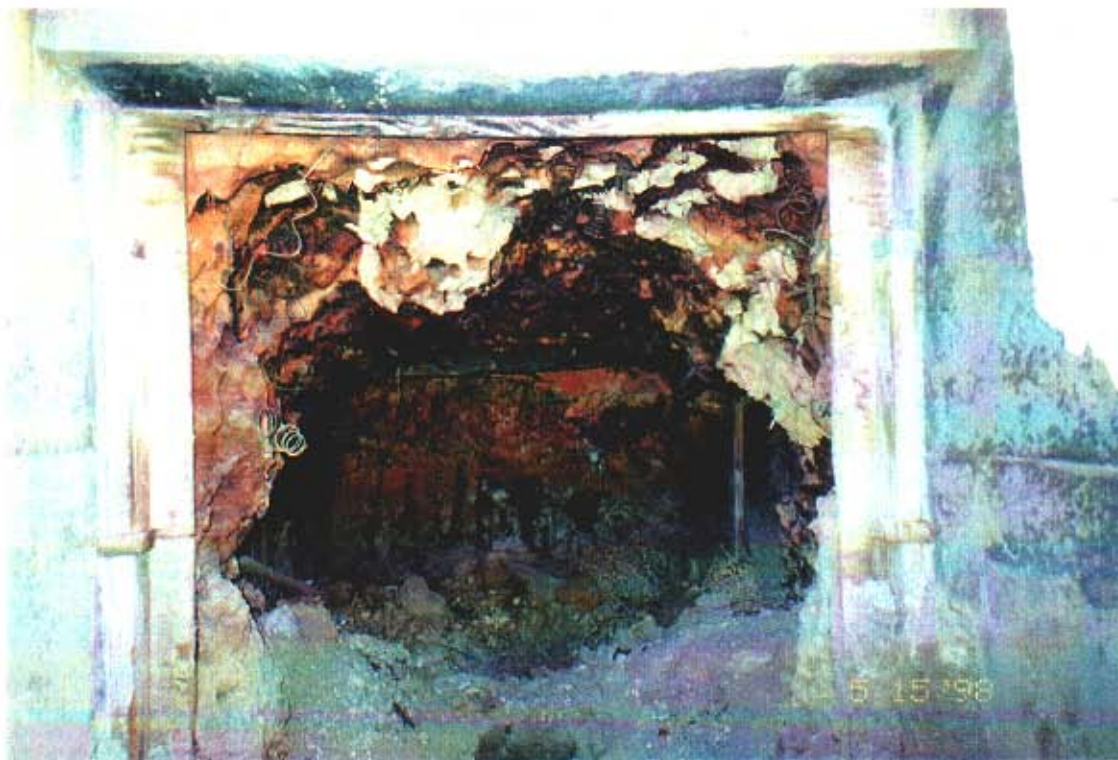
Figure 4.2.1-4b Bunker Interior Showing Burned Soil, Foam, and Wood on the Bunker Floor.

In March 1998 soil samples were collected from immediately inside the bunker door and at approximately the midpoint of the bunker. The bunker had a foam/concrete floor; however, there was no door on the bunker and several feet of soil overlay the floor, which presumably

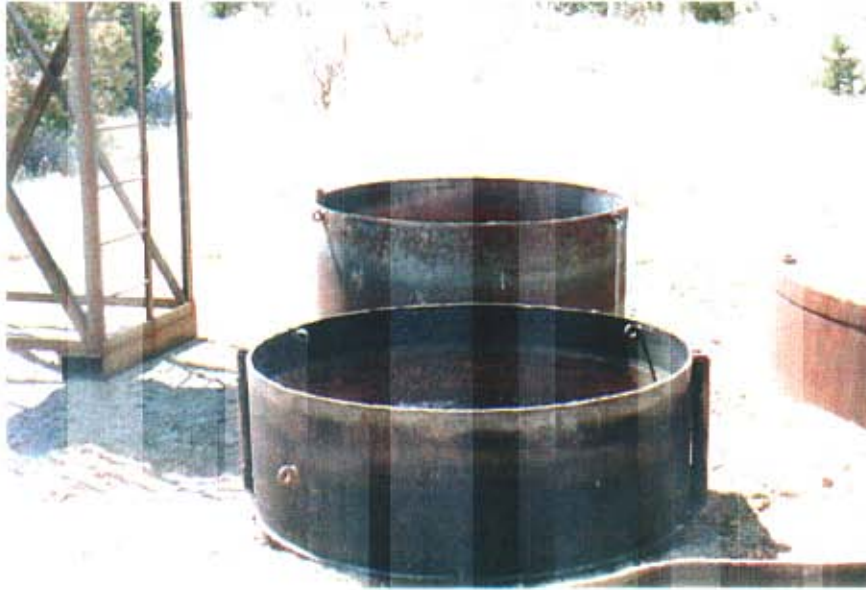
Figure 4A-3
Photograph of Portable Pan

Photograph of portable pans in the southern portion of the scrap yard in April 1995. The pans held JP-4 fuel and water used in small-scale burn tests at SWMU 94.
